# Manhole Inspection Summary

Manhole # S13G1\_007MH

Insp Date: **3/7/08 12:16 PM**

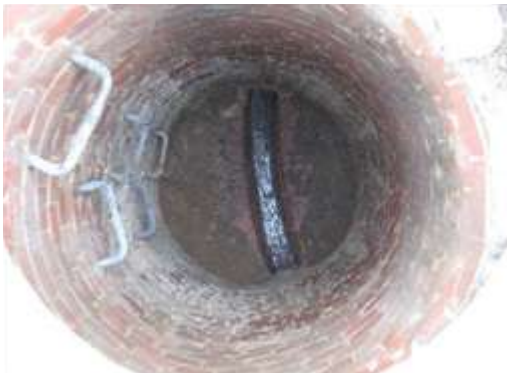
misc

bench debris

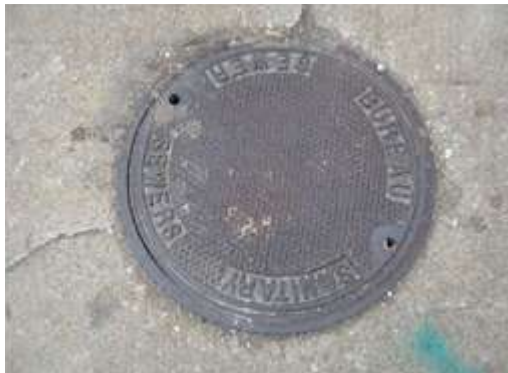
Cover View

Type: **Sanitary** Condition: **Sound** Cover Material: **Cast Iron**

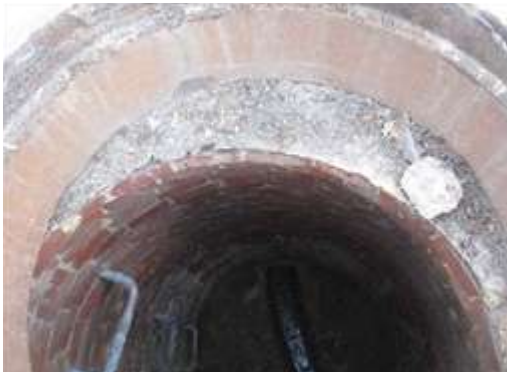
Defect 1

**Frame** Offset: **3** (in.) Condition: ☒ Sound ☐ Cracked ☐ Leaks

offset

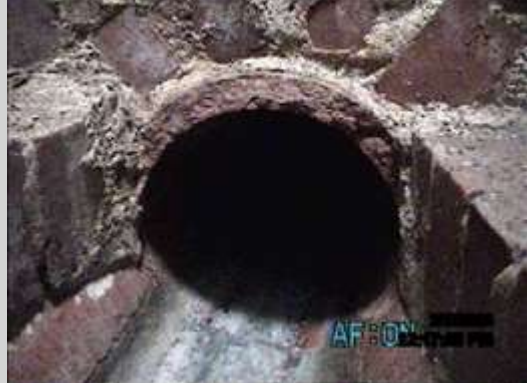
12 O'Clock Outflow

8 in. Circular Gravity Sewer  
Pipe Out @ 12 O'Clock

Pipe Height: **8.4** (in.) Rod and Bar (Angled)  
Pipe Material: **Clay** ☐ Pipe Lined  
Invert Depth: **10.35** (ft.) Flow Characteristics: **Slow**  
Deposits: ☒ None ☐ Mud ☐ Sludge ☐ Debris ☐ Grease  
Silt Depth: **0** (in.) Deposits Extent:  
Infiltration: **None** Pipe Seal Cond: **Sound**

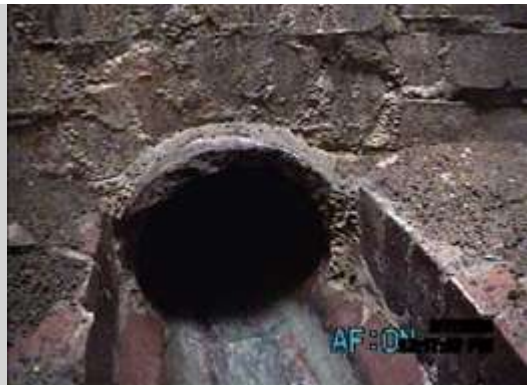
5 O'Clock Inflow

8 in. Circular Gravity Sewer  
Pipe In @ 5 O'Clock

Pipe Height: **8.4** (in.) Rod and Bar (Angled)  
Pipe Material: **Clay** ☐ Pipe Lined  
Invert Depth: **10.10** (ft.) Flow Characteristics: **Fast**  
Deposits: ☒ None ☐ Mud ☐ Sludge ☐ Debris ☐ Grease  
Silt Depth: **0** (in.) Deposits Extent:  
Infiltration: **None** Pipe Seal Cond: **Sound**
